Advanced Stirling Radioisotope Generator EU2 Anomaly Investigation

The Advanced Stirling Radioisotope Generator (ASRG) Engineering Unit 2 (EU2) is the highest fidelity electrically-heated Stirling radioisotope generator built to date. NASA Glenn Research Center (GRC) completed the assembly of the ASRG EU2 in September, 2014 using hardware from the now cancelled ASRG flight development project. The ASRG EU2 integrated the first pair of Sunpower's ASC-E3 Stirling convertors (ASC-E3 #1 and #2) in an aluminum generator housing with Lockheed Martin's Engineering Development Unit (EDU) 4 controller. After just 179 hours of EU2 generator operation, the first power fluctuation occurred on ASC-E3 #1. The first power fluctuation occurred 175 hours later on ASC-E3 #2. Over time, the power fluctuations became more frequent on both convertors and larger in magnitude. Eventually the EU2 was shut down in January, 2015. An anomaly investigation was chartered to determine root cause of the power fluctuations and other anomalous observations. A team with members from GRC, Sunpower, and Lockheed Martin conducted a thorough investigation of the EU2 anomalies. Findings from the EU2 disassembly identif

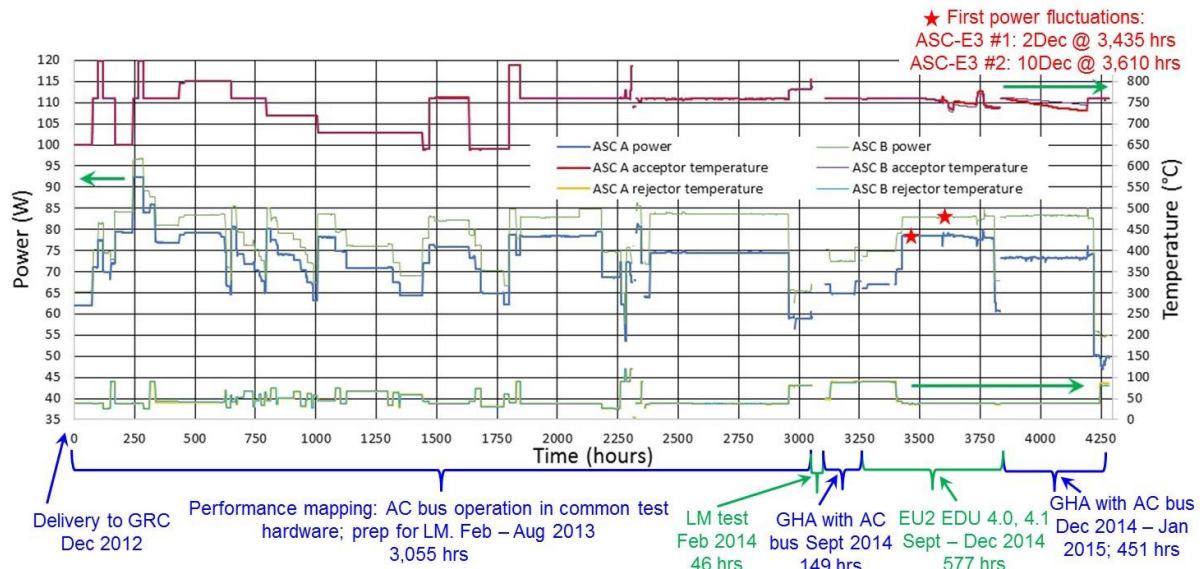
Figure 3. ASC-E3 #1 and #2 operating history.

(See Fig. 3). Then 175 hours later the first power fluctuation occurred on ASC-E3 #2 (0.2 W drop). Figure 4 shows the power fluctuations observed on ASC-E3 #1 and #2 during EU2 operation, which appear as short duration decreases in power. Some power fluctuations were as small as 0.2 to 0.4 W and lasted less than two seconds. Over time they became more frequent and greater in magnitude, with some power fluctuations becoming as large as 9 W and lasting for many minutes, if not hours.

The fifth observation was an increase in the current required to move the pistons in the convertors. The ASC start-up procedure includes applying a DC current to the alternator to move the piston to a certain position. Beginning with the restart under AC bus control (at 3,833 hours in Fig. 3), the current to move ASC-E3 #1's piston was as much as five times the nominal value. The current to move ASC-E3 #2's piston was abnormally high as well.

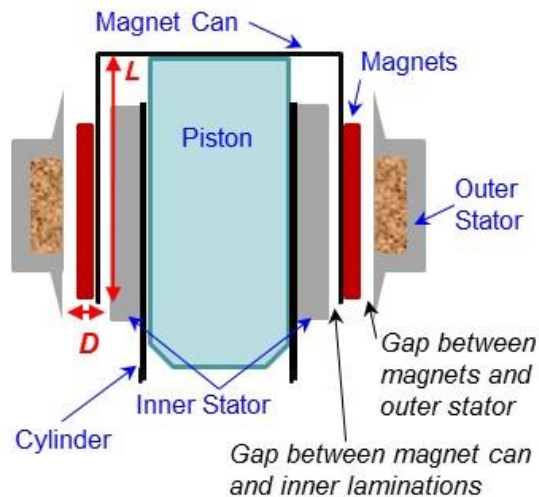
Figure 9. Cross-section of ASC alternator showing location of air gaps.

Findings from the drop tests showed that because the surface that the magnet can beams contacted on the ASC-E3 #1 cylinder was not flat, the collision would introduce a rocking motion in the magnet can, which could result in contact between the magnets and the outer stator (location 6 in Fig. 8, see also Figs. 9 and 11). If the rocking amplitude is large enough, the magnet can could also contact the inner stator (location 7 in Fig. 8, see also Figs. 9 and 11). The drop tests showed that with sufficiently high impact velocities and number of drops, collisions could

The magnet can clearance theory postulates that insufficient running clearance, possibly in combination with imperfect alignment of the magnet can within the air gap between the inner stator and the outer stator (Fig. 9), could not accommodate all thermal and dynamic effects encountered during operation. This would result in rubbing contact between the magnets and outer stator and/or between the magnet can and the inner stator, initiating damage and eventual failure.

The second aspect is associated with the relatively tight alternator air gaps in the ASC alternator. The ASC alternator air gap in combination with the magnet can’s high L/D ratio (see Fig. 9) is challenging to manufacture, and creates potential failure modes that reduce robustness to unacceptable levels for a critical component in a nuclear power system.
